# Merriwether-Cherokee Potamology Study

MRG&P Report No. 9 • May 2017

# **Merriwether-Cherokee Potamology Study**

Brian M. Hall, Roger A. Gaines, L. Yu Lin, and Kandi H. Waller

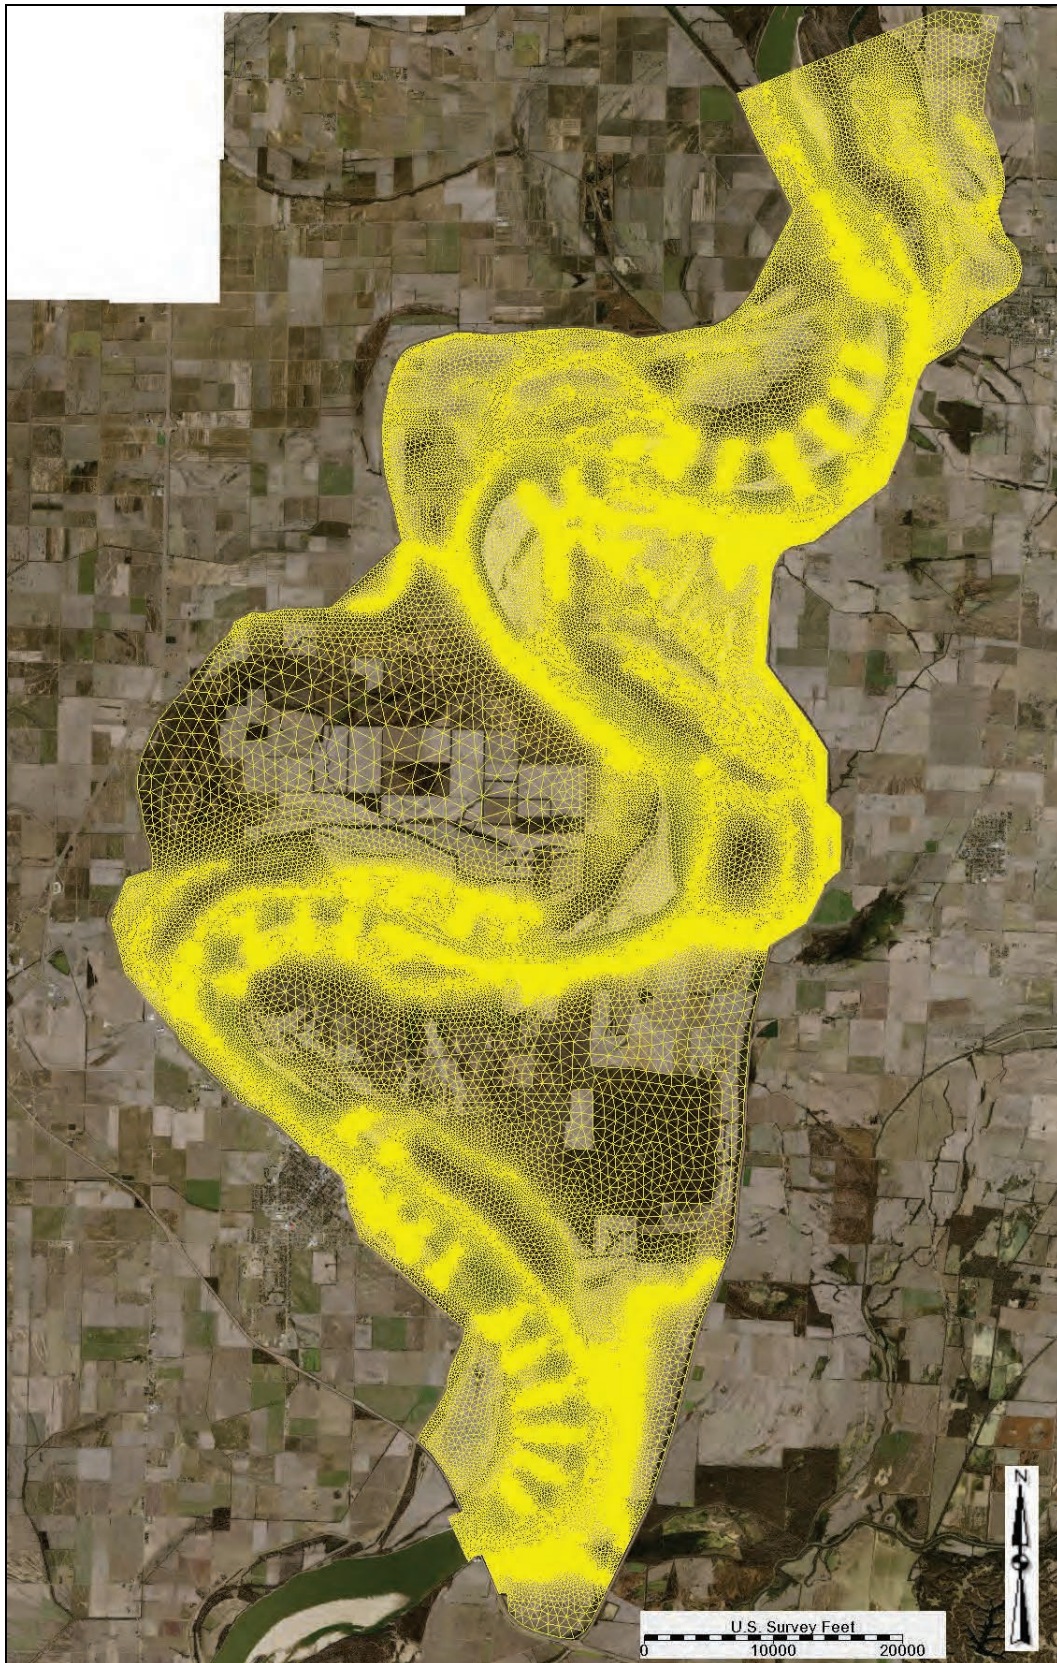
Figure 2-16. Base condition element mesh for AdH model (entire model).

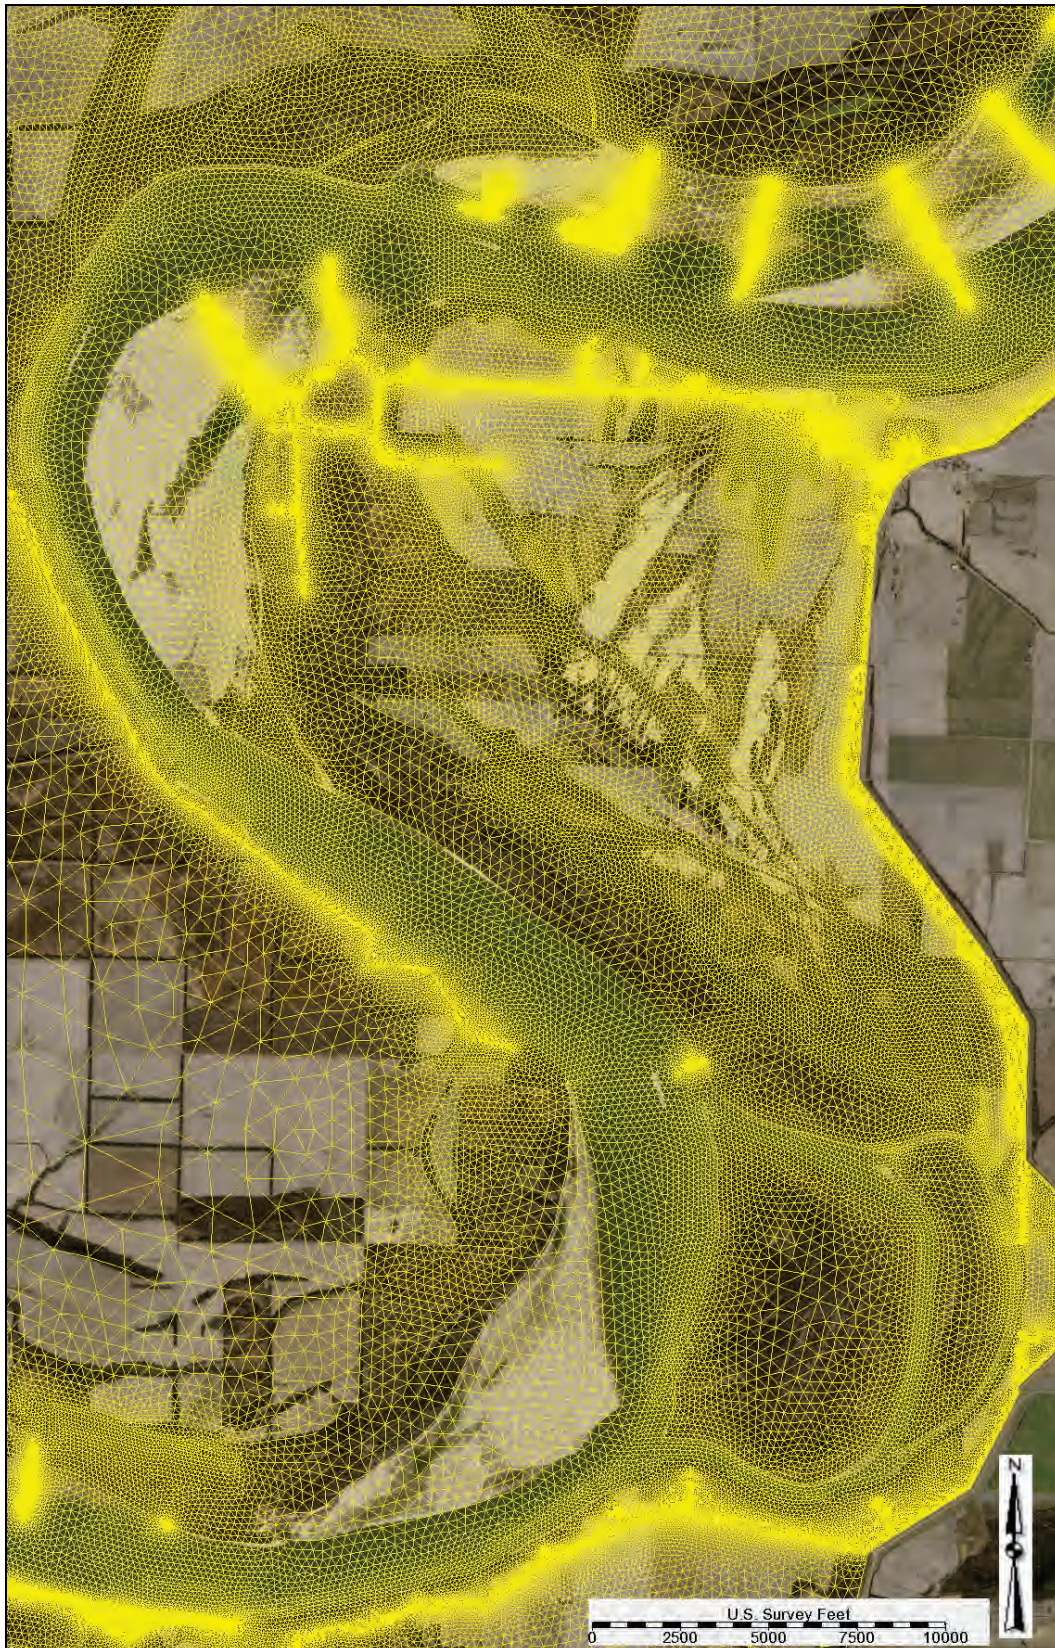
Figure 2-17. Base condition element mesh for AdH model (study overbank).

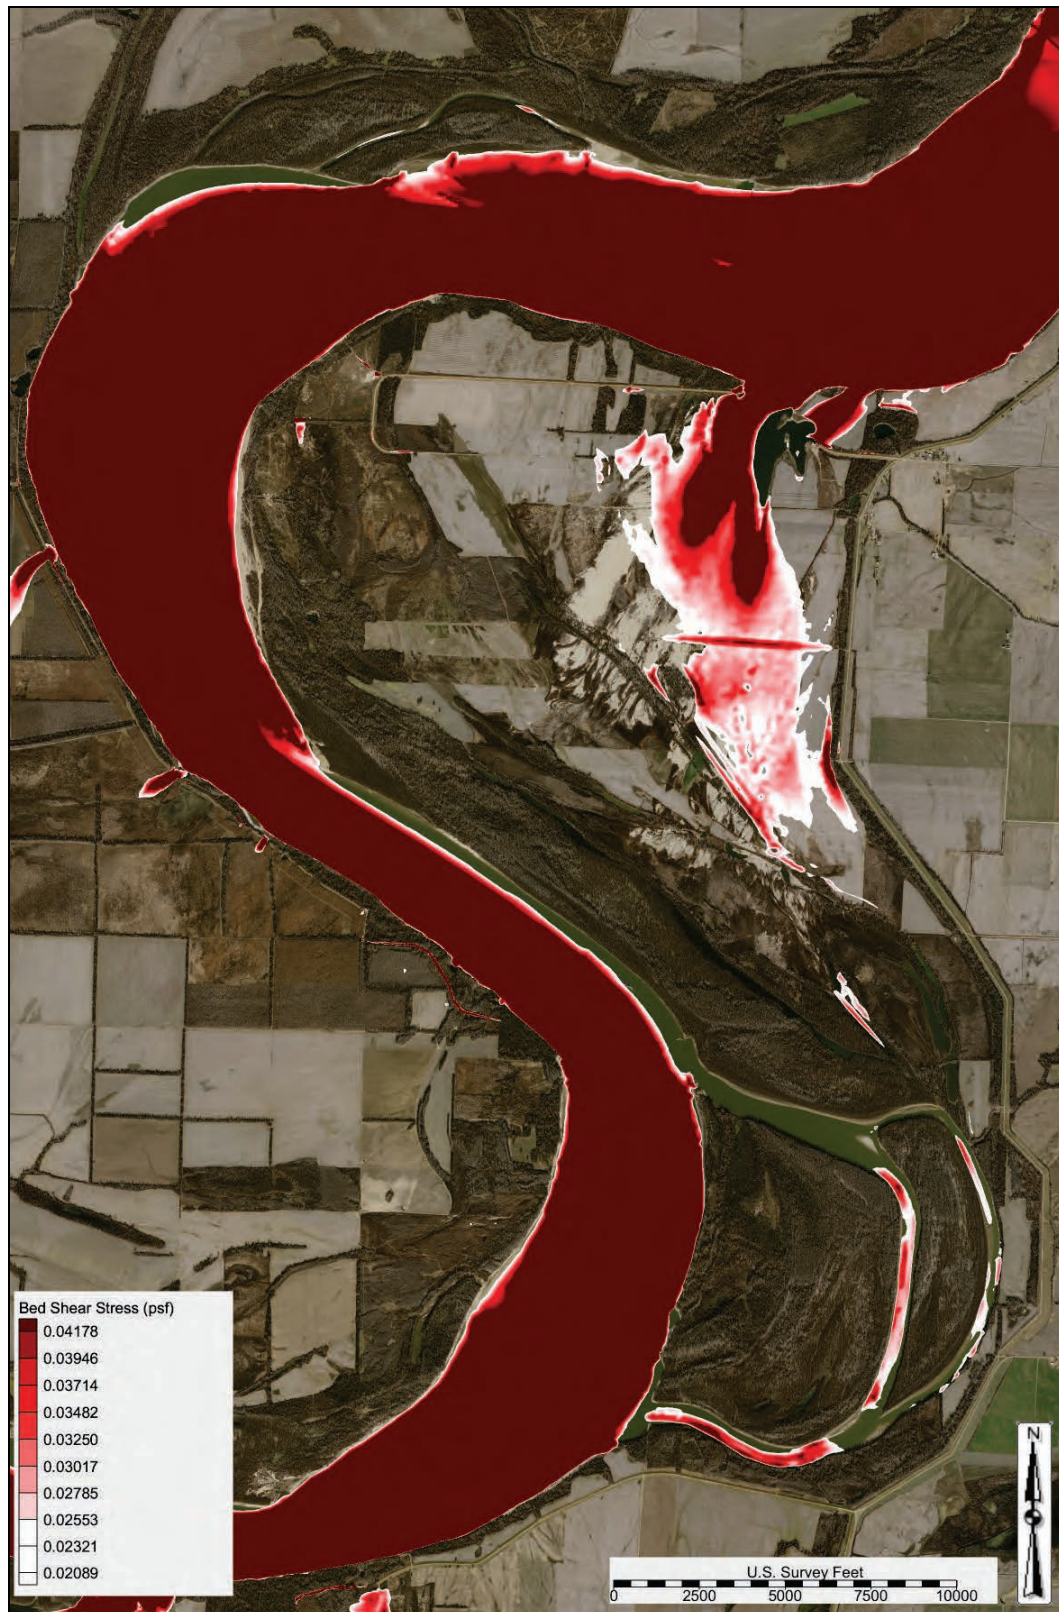
Figure 2-34. Base condition shear stress—1,900,000 cfs (study overbank).

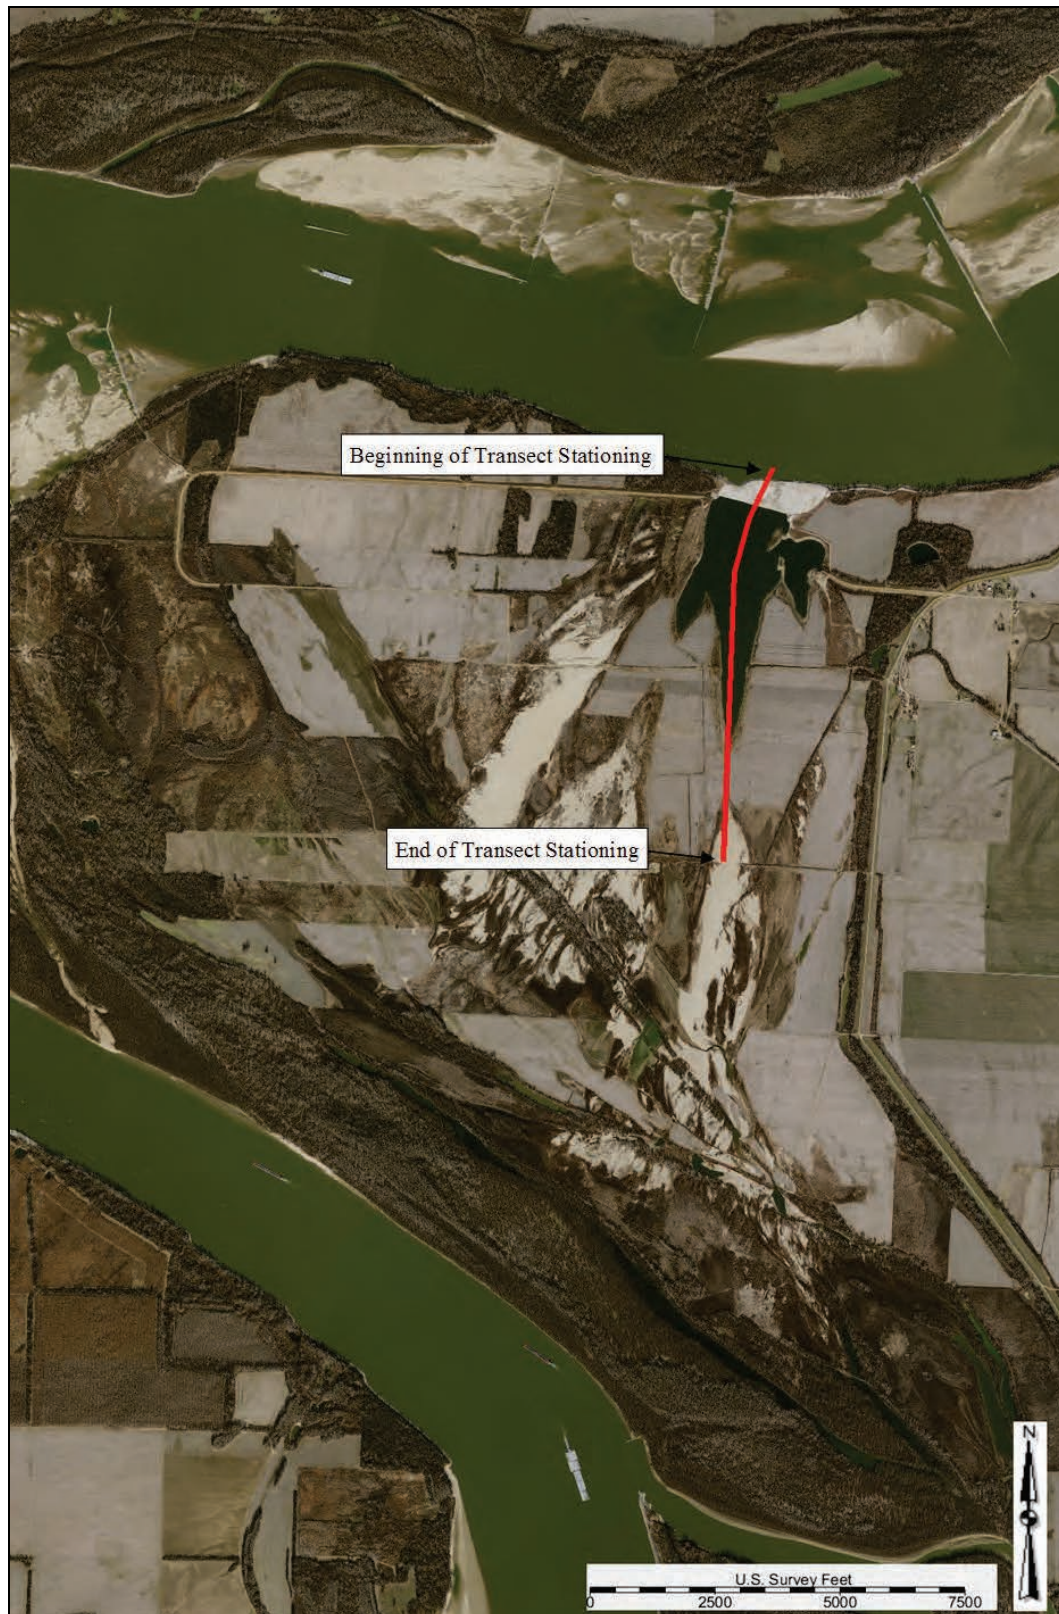
Figure 2-47. Crevasse WSEL transect location.

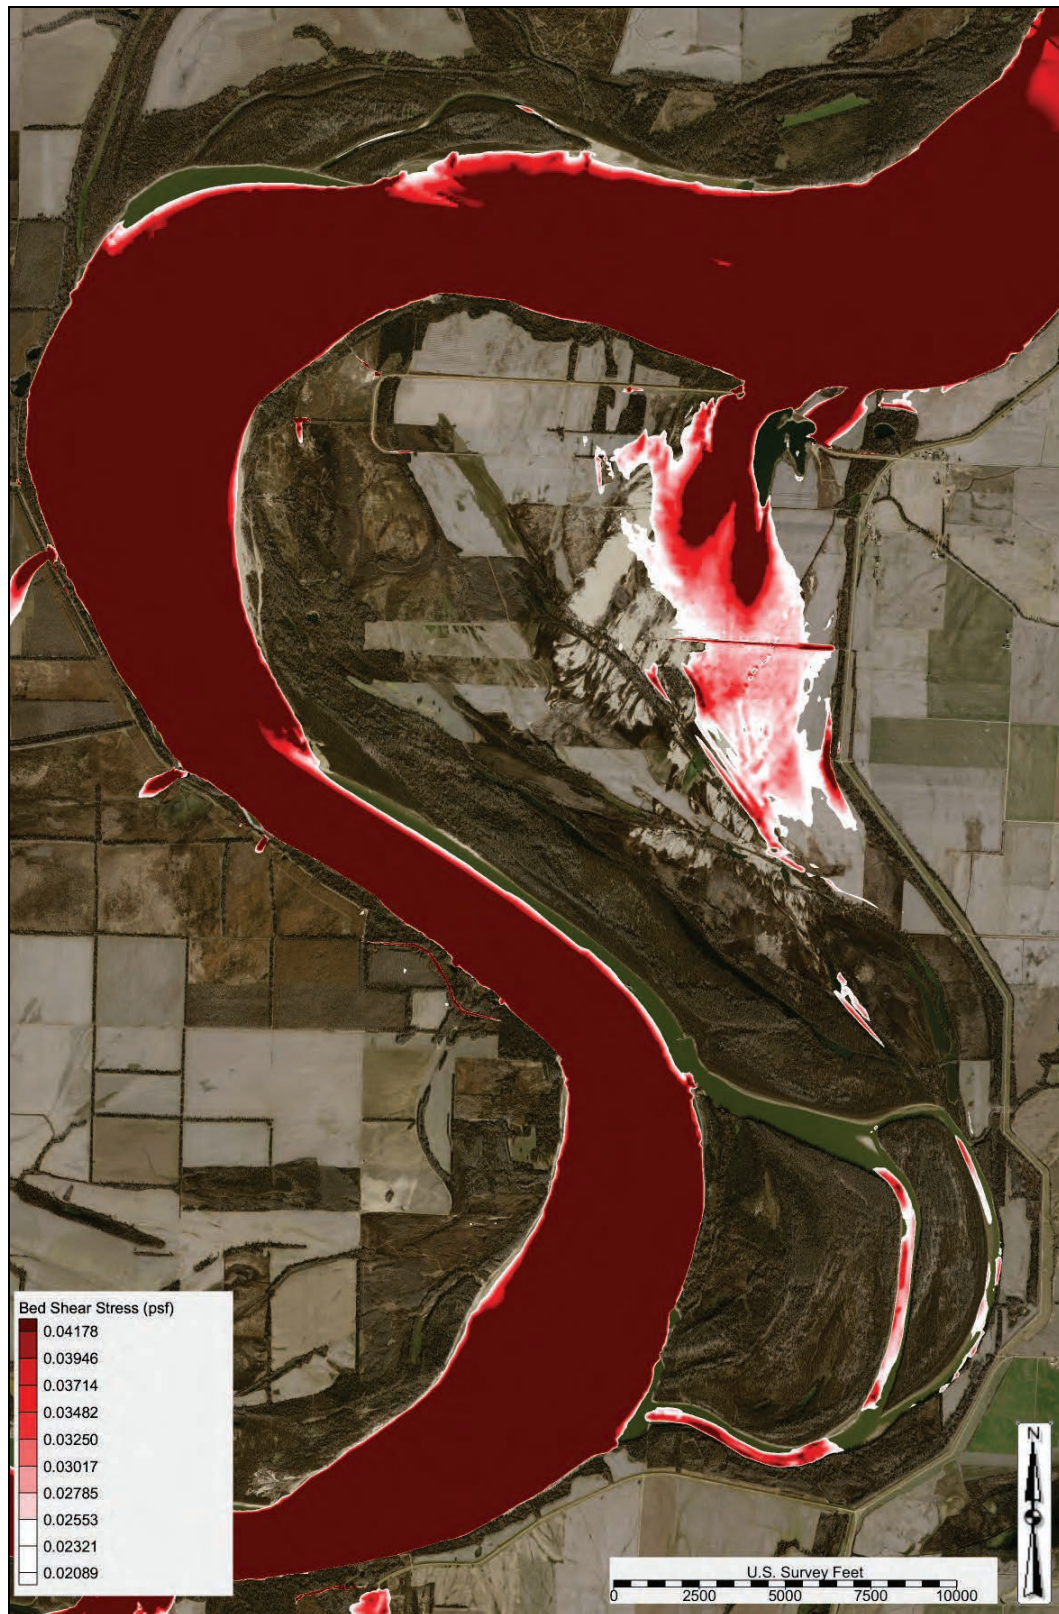
Figure 3-17. Alternative 4 shear stress—1,900,000 cfs (study overbank).

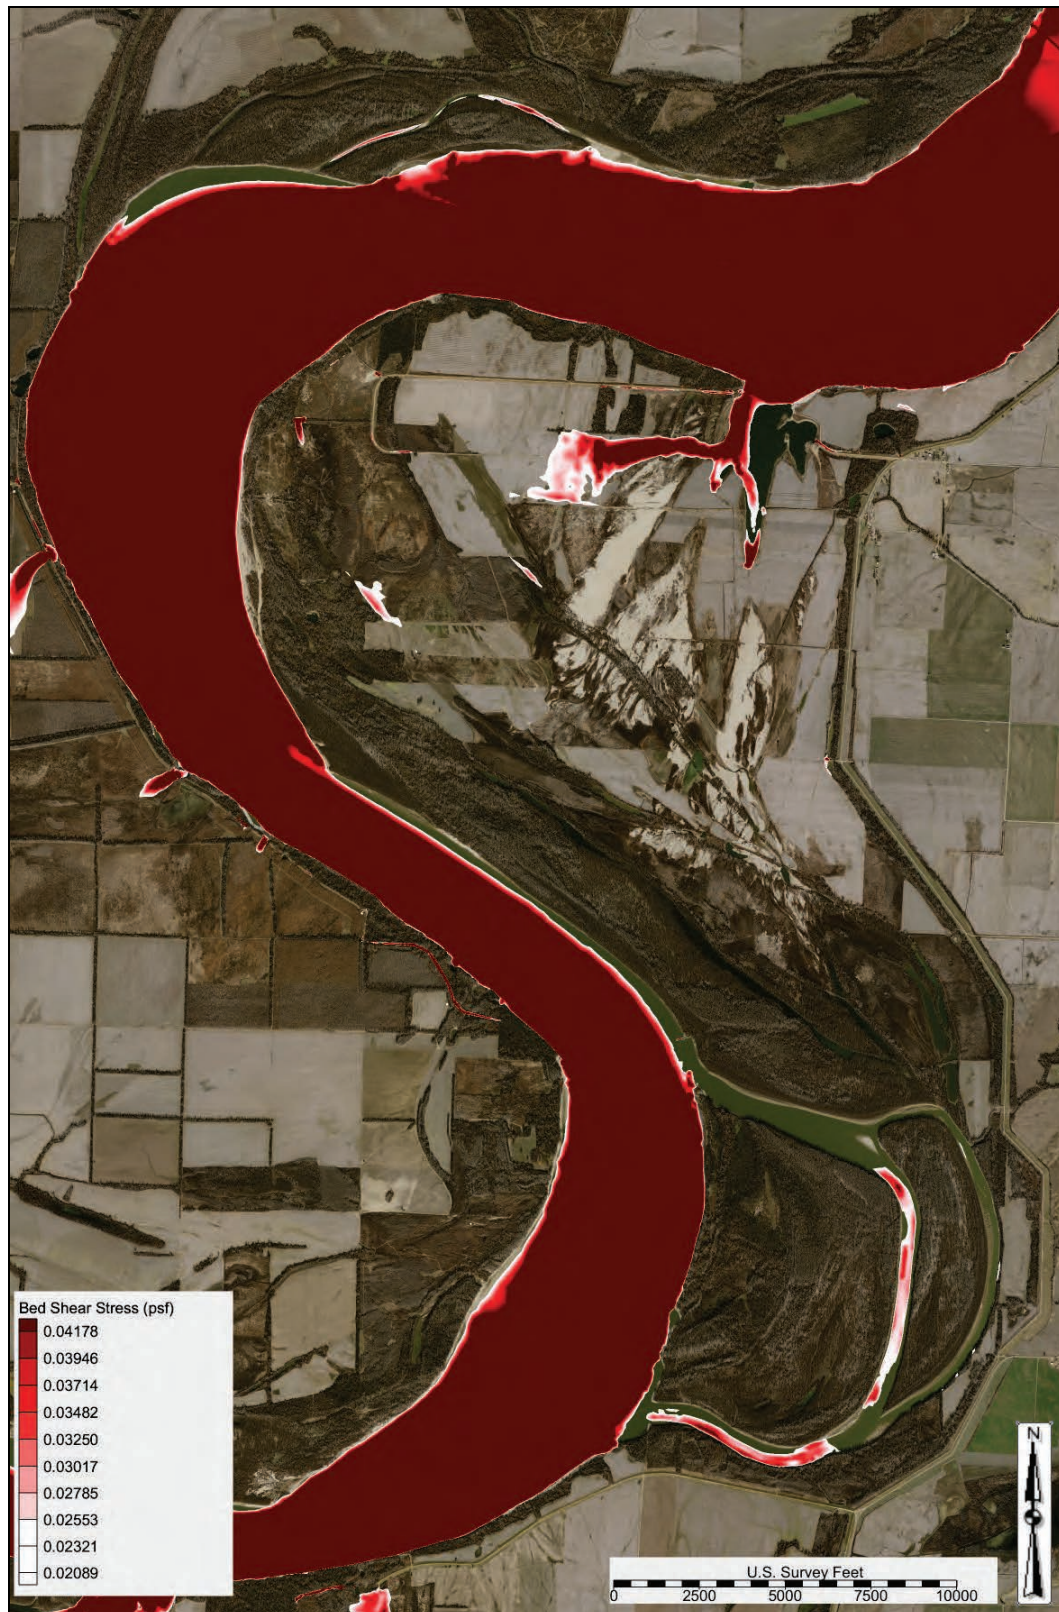
Figure 3-21. Alternative 6 shear stress—1,900,000 cfs (study overbank).

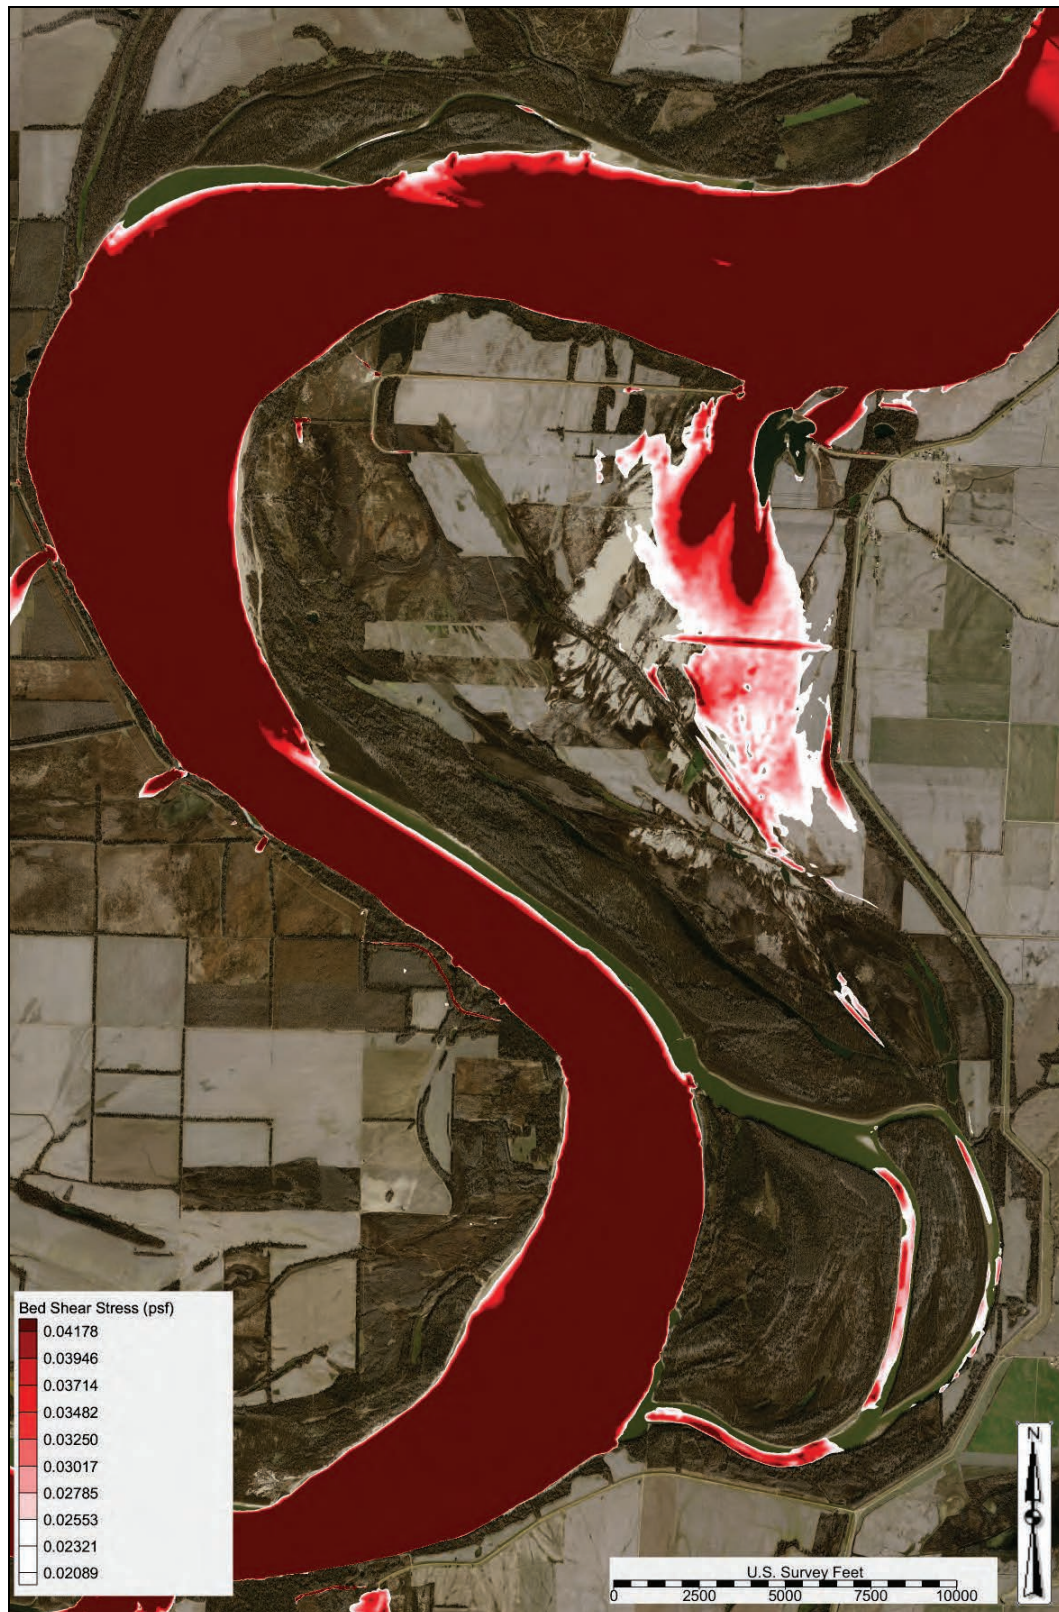
Figure 4-4. Local Scour Countermeasure 1 shear stress—1,900,000 cfs (study overbank).

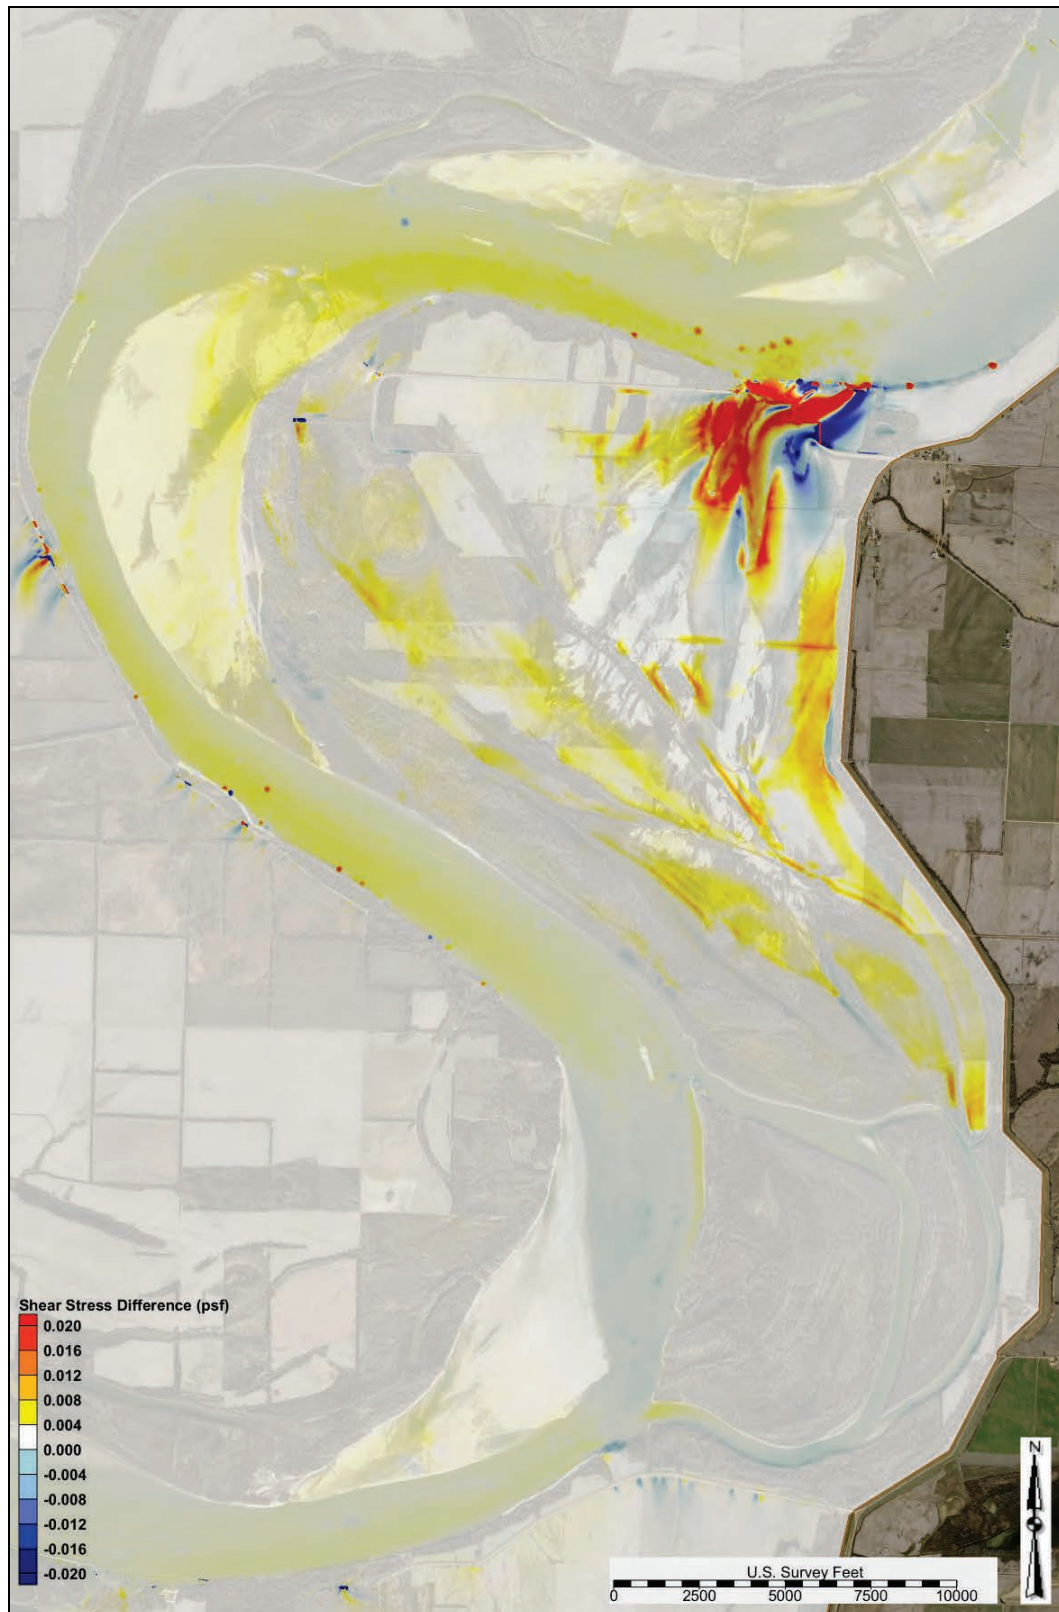
Figure 4-7. Local Scour Countermeasure 2 shear stress difference—1,900,000 cfs.

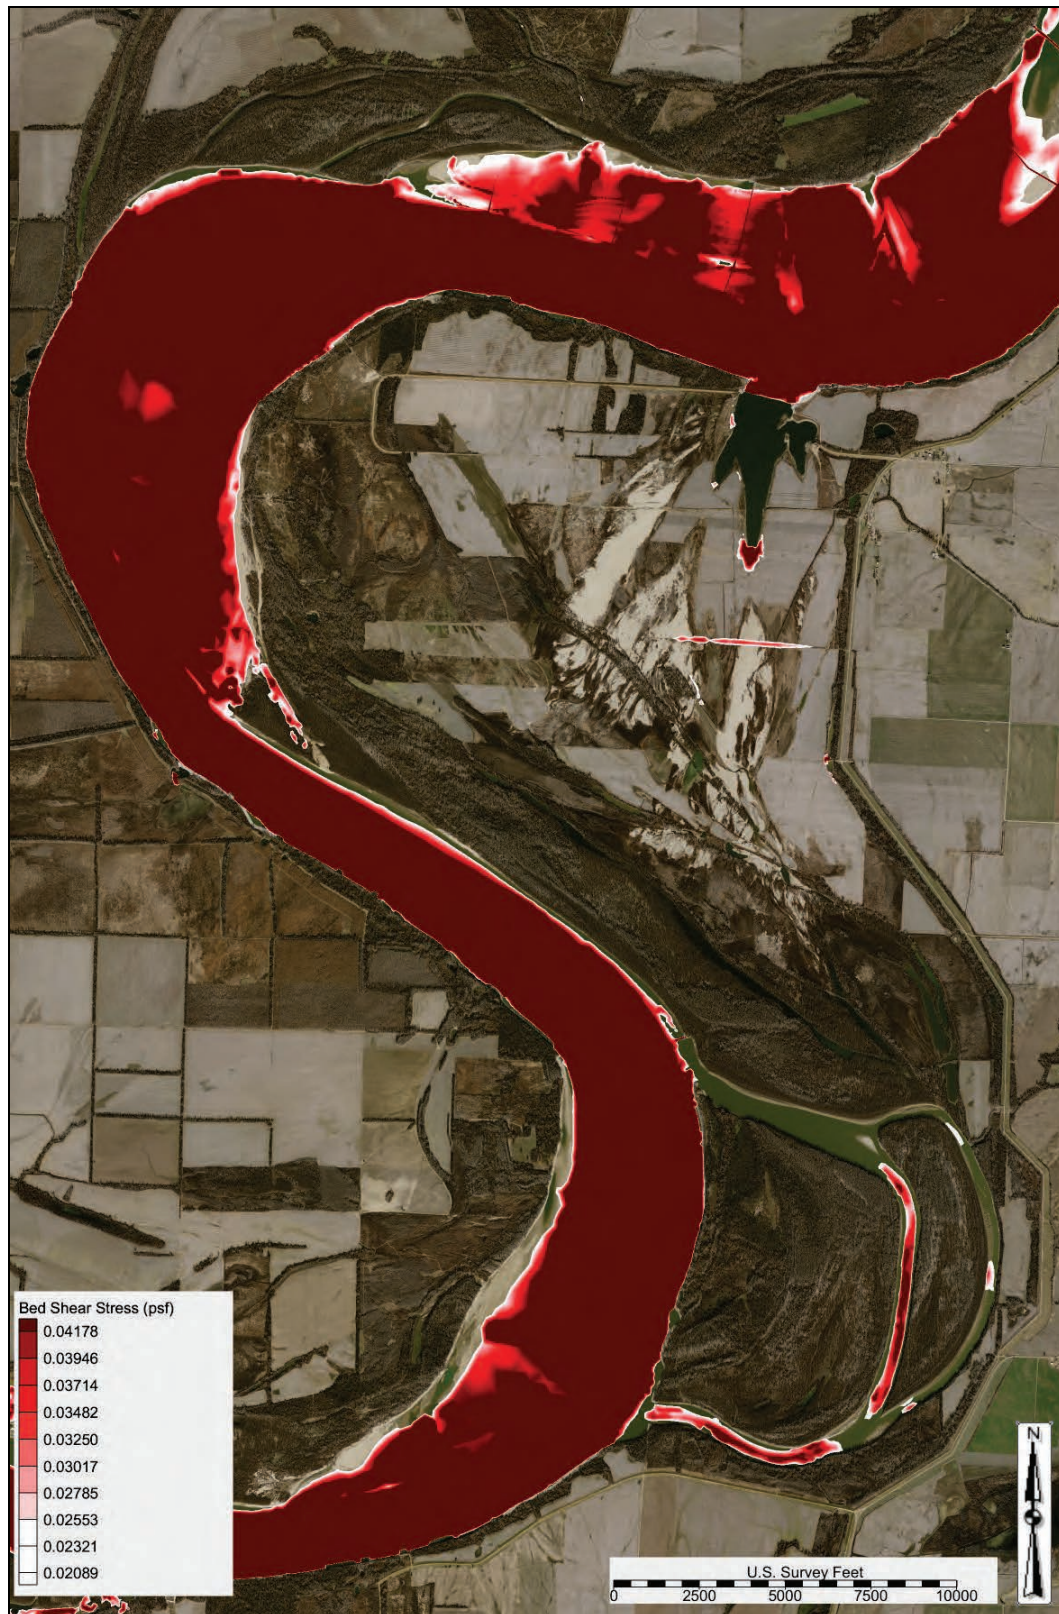
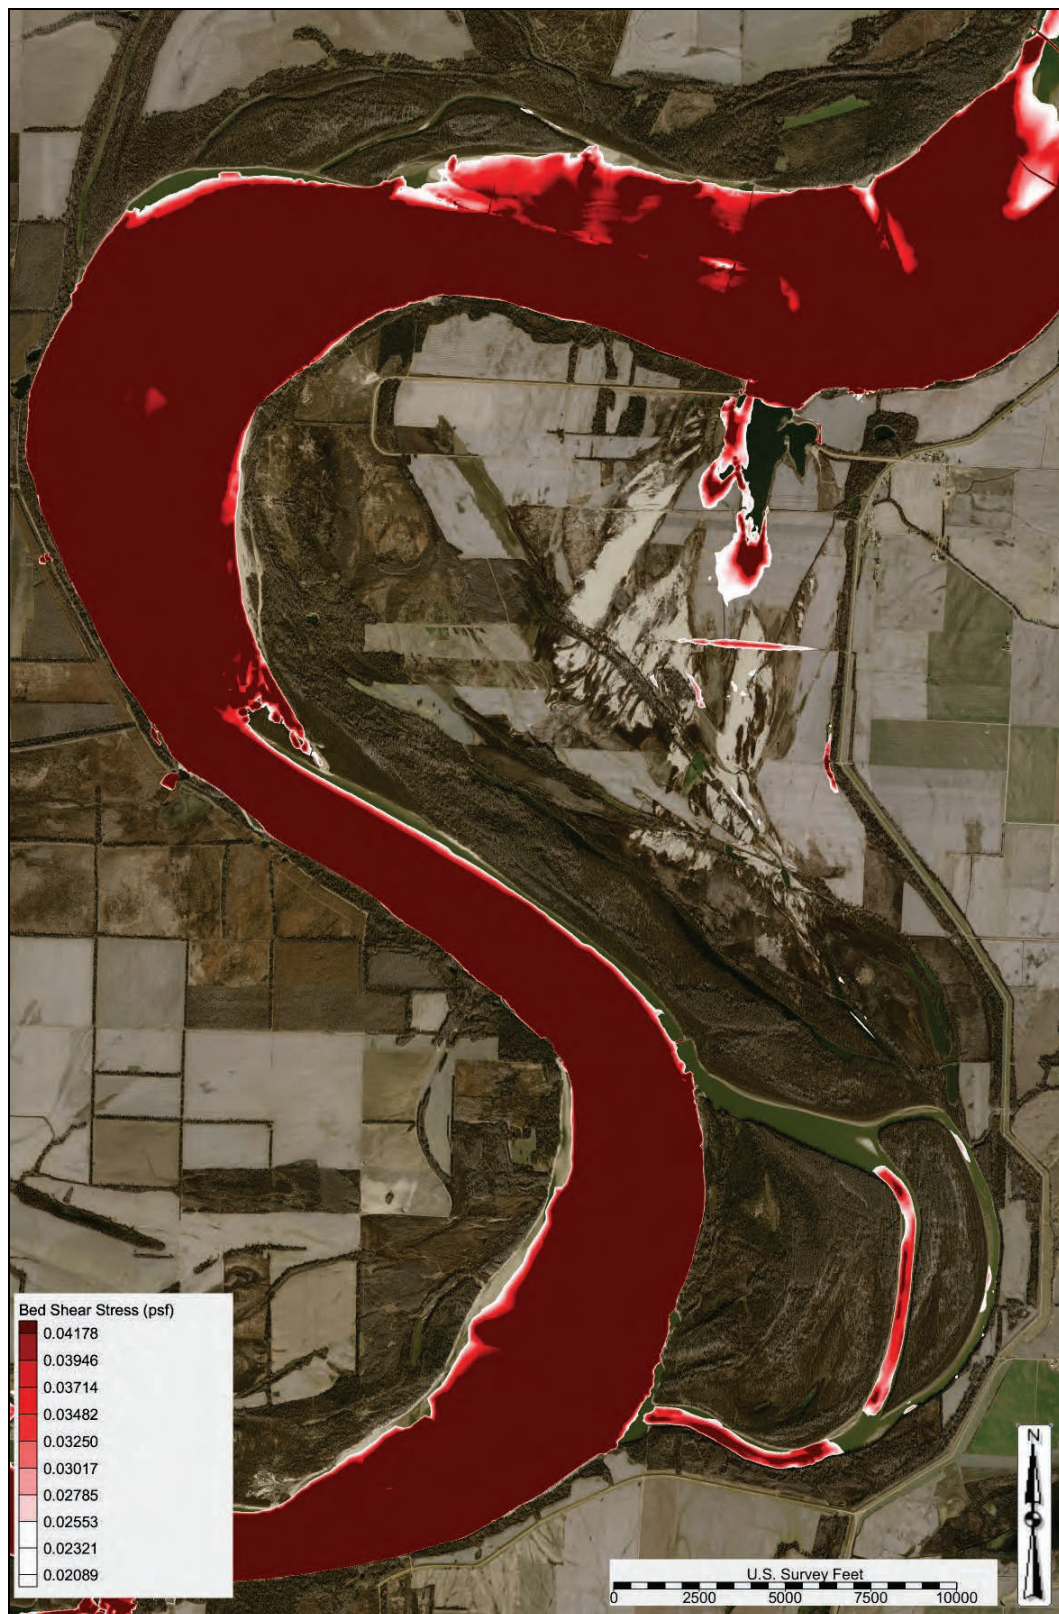
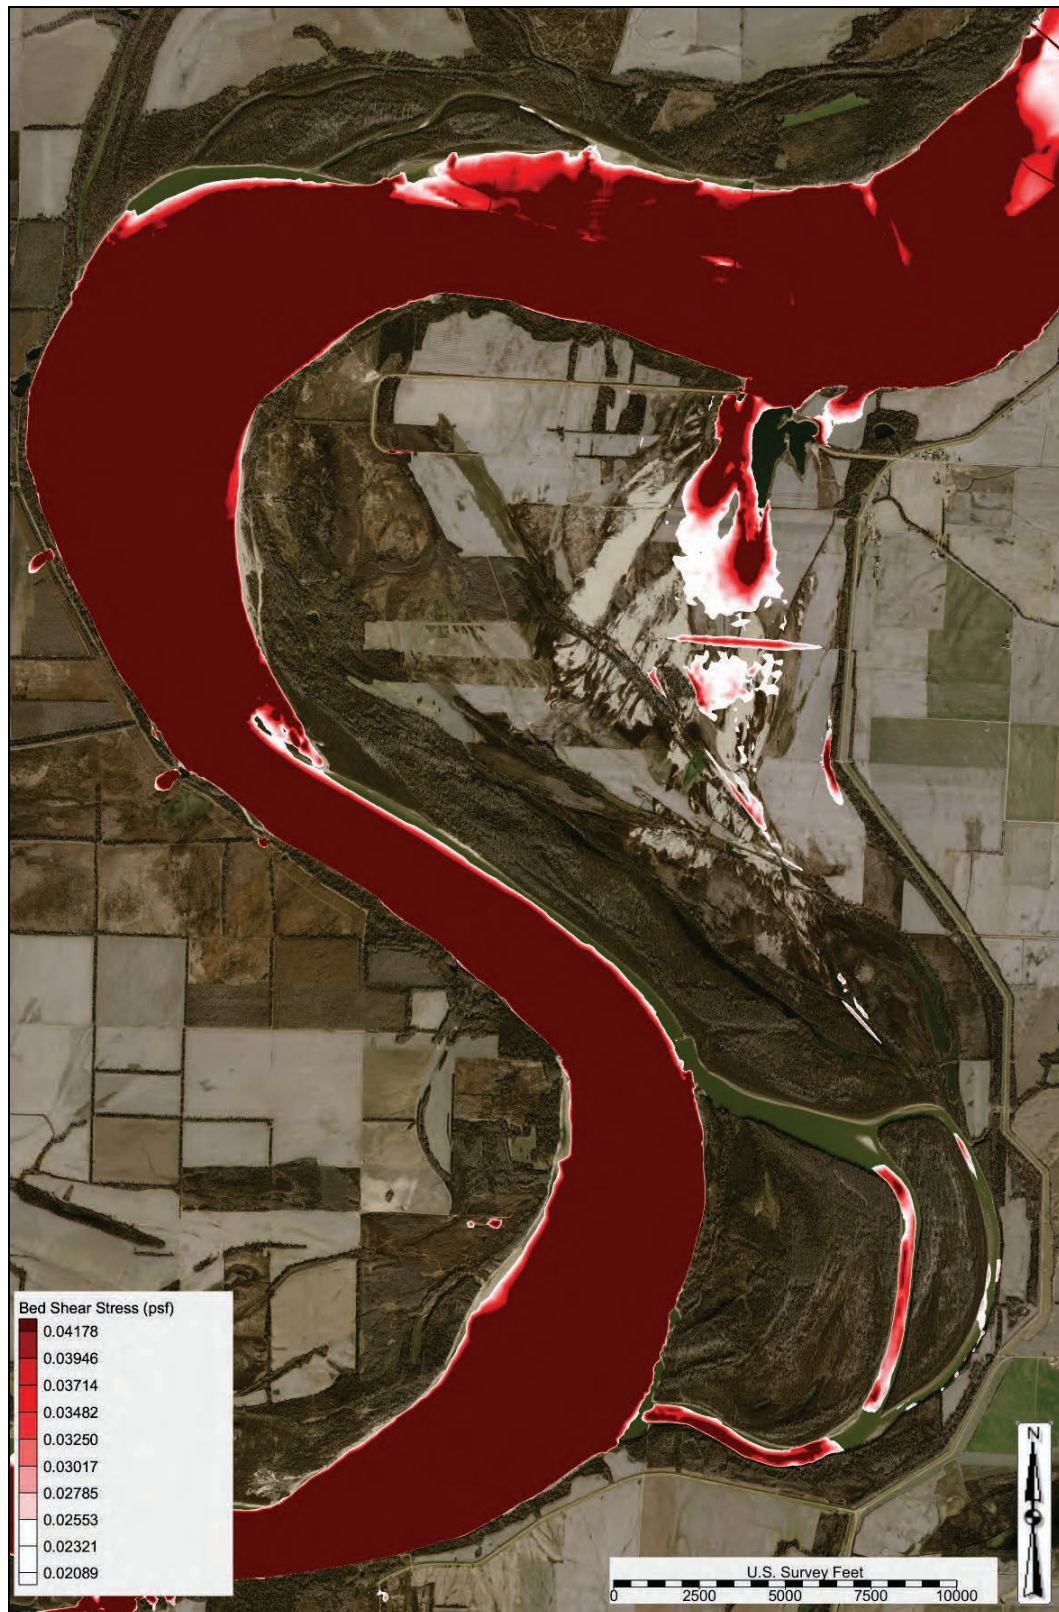
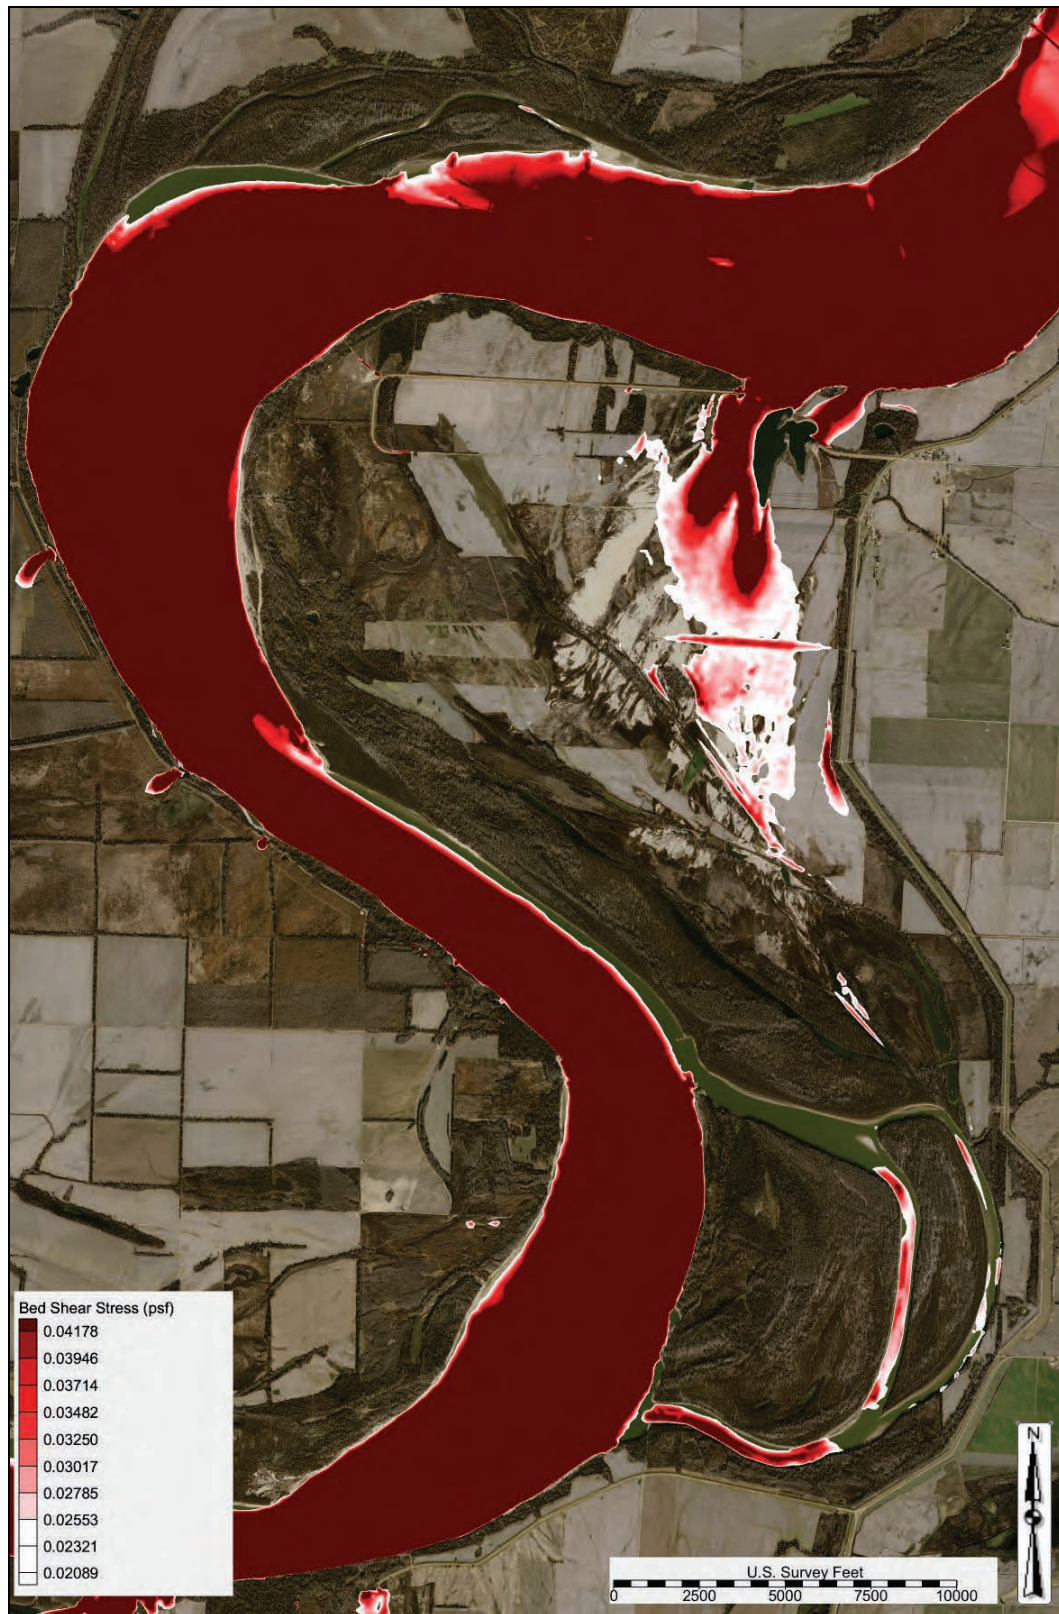
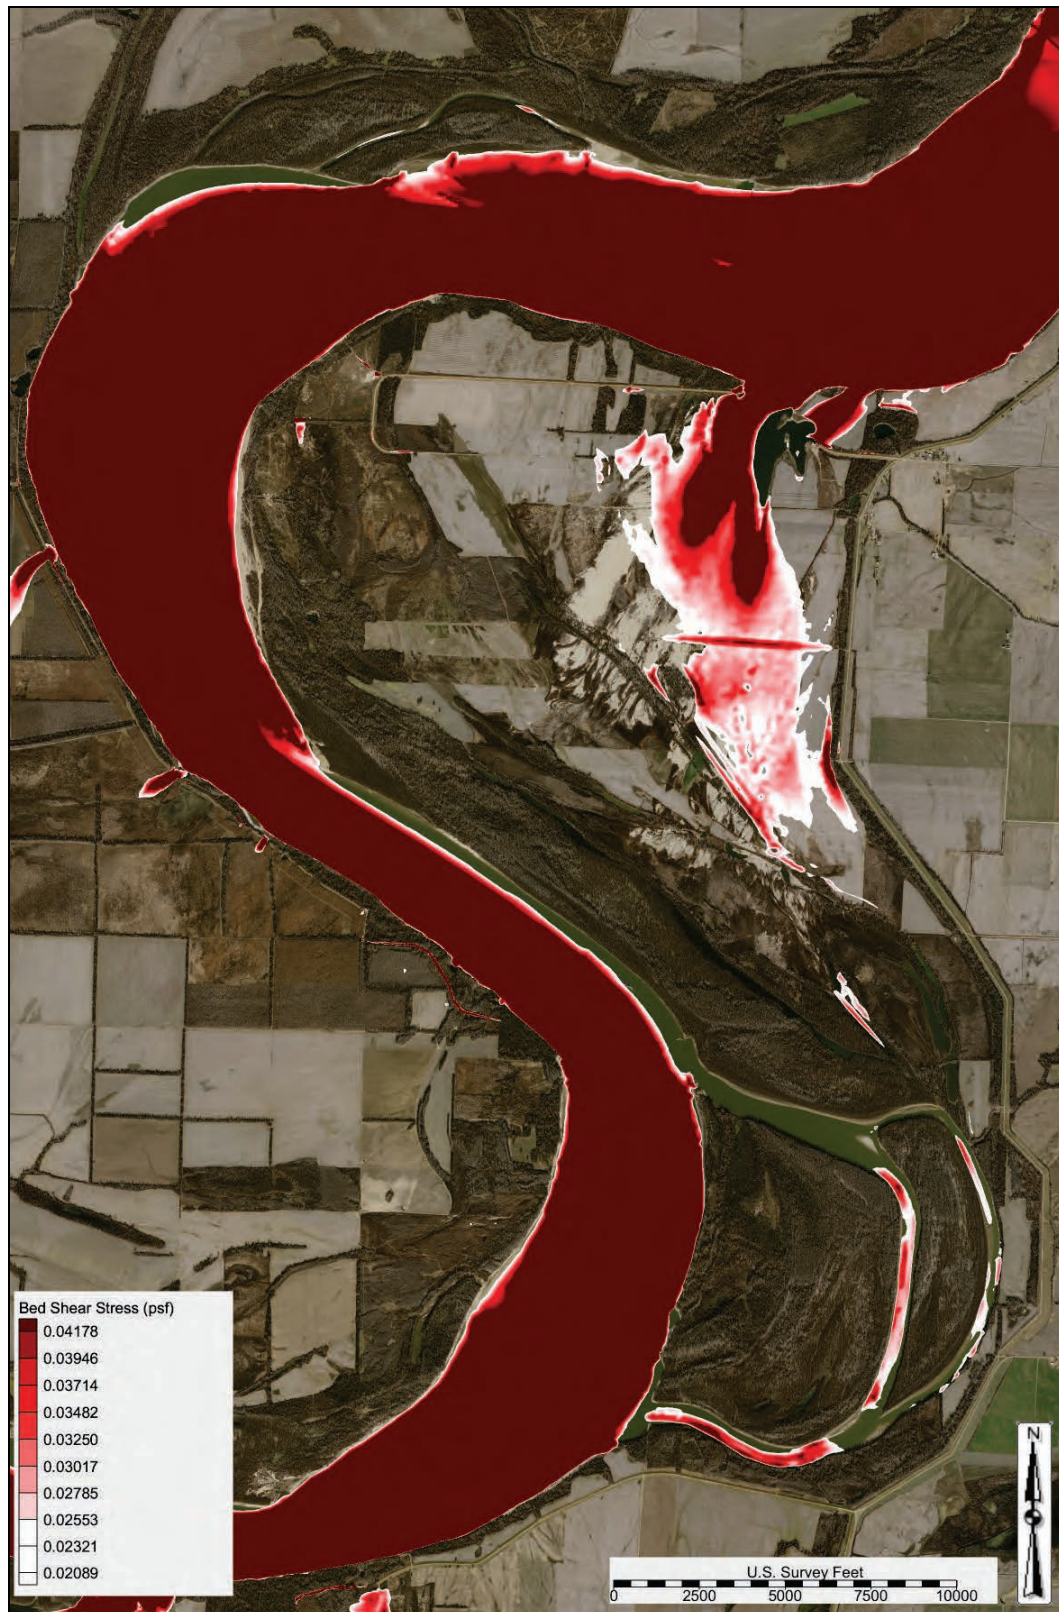
Figure C-87. Base condition shear stress—1,100,000 cfs (study overbank).

Figure C-88. Base condition shear stress—1,300,000 cfs (study overbank).

Figure C-89. Base condition shear stress—1,500,000 cfs (study overbank).

Figure C-90. Base condition shear stress—1,700,000 cfs (study overbank).

Figure C-91. Base condition shear stress—1,900,000 cfs (study overbank).

The modeled shear stress outputs at flows ranging from 900,000 to 2,100,000 cfs for the study overbank are depicted in Figures C-86 through C-92.
